LTHW & Ch W SERVICES

PLASTIC TO IRON CONNECTIONS TO COMMISSIONING STATIONS

Number of sheets in report 11
Date updated June 2013

CONTRACT Bad connections at commissioning stations

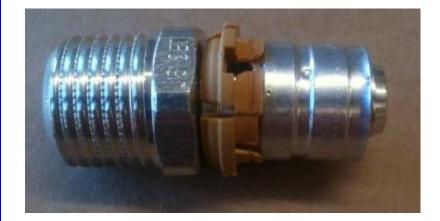
15mm connector fitted direct to commissioning station

Plastic to iron connector used.

Plastic pipe installations should therefore always have a copper or steel section to connect to the commissioning station.

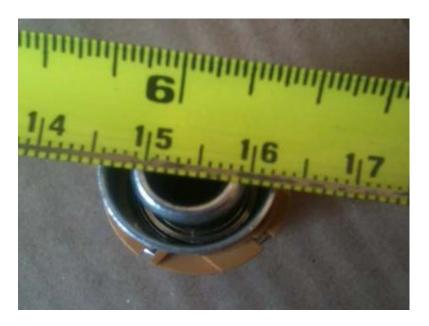
Inlet side from plastic pipe side showing 8 mm dia internal size through which the water passes.+

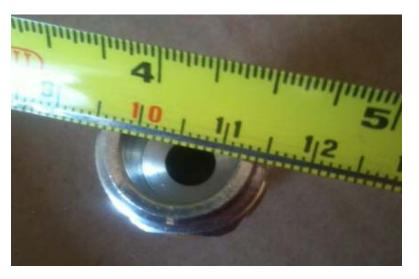
Discharge side to the CS. 8 mm dia hole discharging towards the CS measuring points which gives a high velocity jetting effect as it expands to the 15 mm dia.

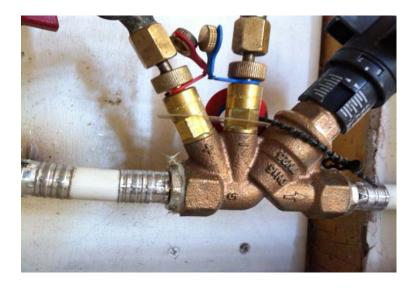
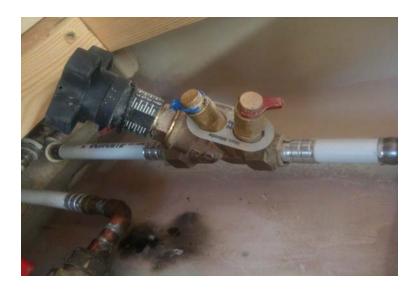
15mm connector fitted direct to commissioning station

Typical commissioning station with plastic in and out.

The connections on both sides of the 15 mm CS have 8 mm internal diameter.

That gives jetting on the inlet and the equivalent of hitting a partial wall on the discharge. Any reading from the CS would be meaningless.

Commissioning stations should have, as an absolute minimum, a length of 5 diameters of straight pipe with internal diameter equal to the valve size.

On the discharge side, this should be a mimimum length of 2½ diameters.

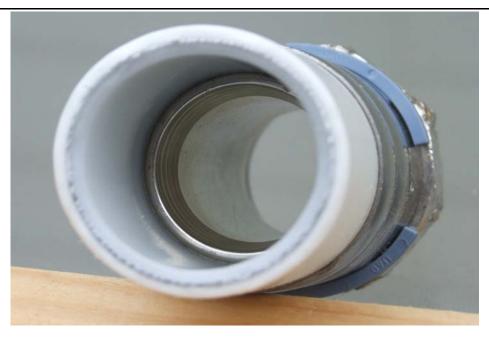
32mm connector fitted direct to commissioning station

Inlet side from plastic pipe The strengthener inside acts like a reducing bush followed by a short taper.

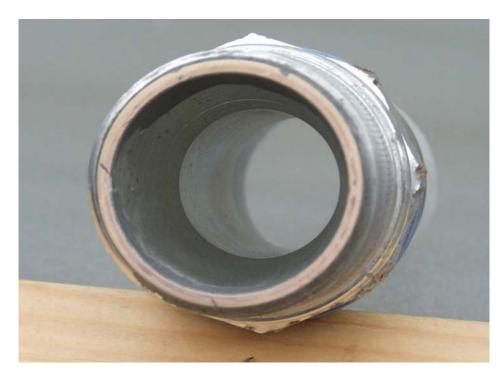
Discharge side into commissioning station

Taper out to the commissioning station connection

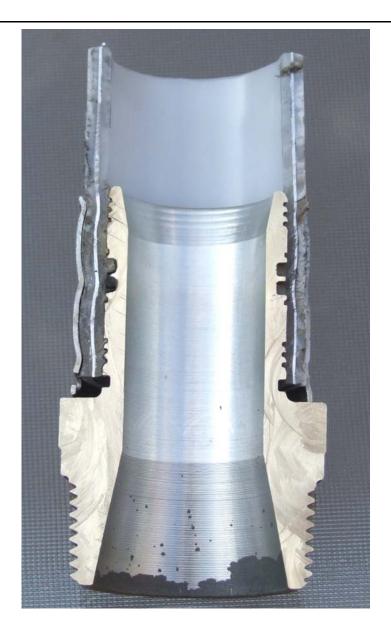
32mm connector was fitted direct to commissioning station

Connector sliced in half to show internals.

Initial readings from the commissioning station that this was connected to gave a variety of signals that indicated zero flow up to 42 % of the required flow rate. The pipe was altered to give a length of straight copper on either side instead, using standard copper to iron connectors

With the new configuration, the signal was stable and indicated a flow rate of 115% of the desired figure.

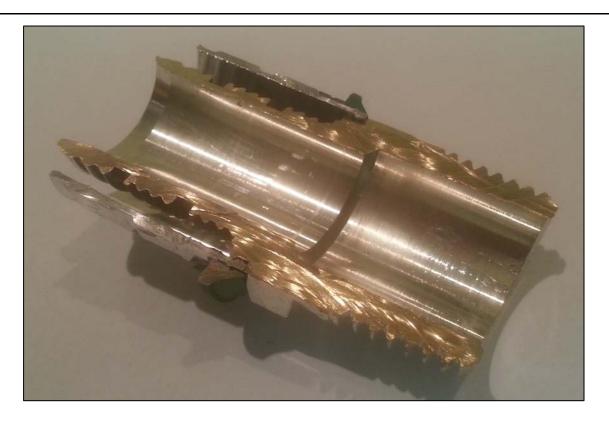
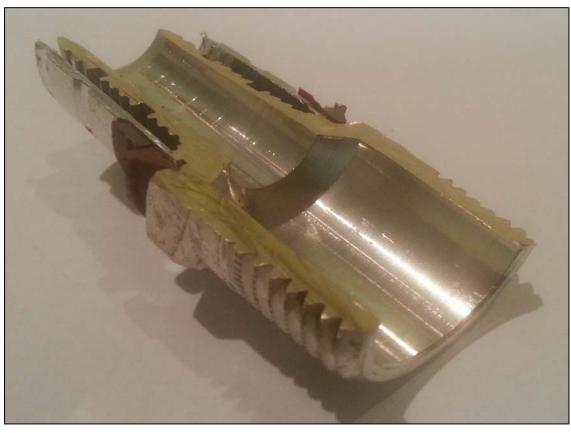
Both are 25mm connector which were fitted direct to commissioning stations

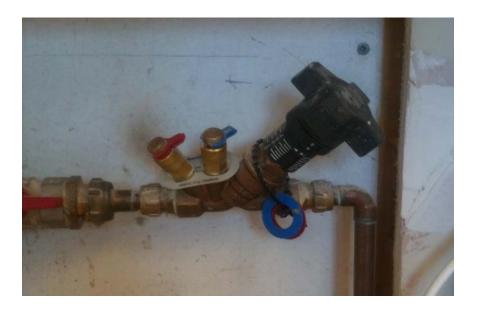
A square reducer close to the CS inlet giving turbulence to the water flow as it approaches the test points. Thus a meaningless reading.

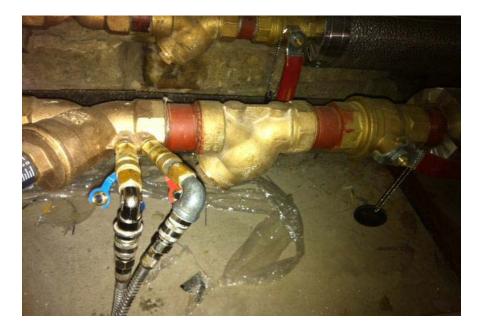
A strainer close to the CS inlet giving turbulence to the water flow as it approaches the test points. Thus a meaningless reading.

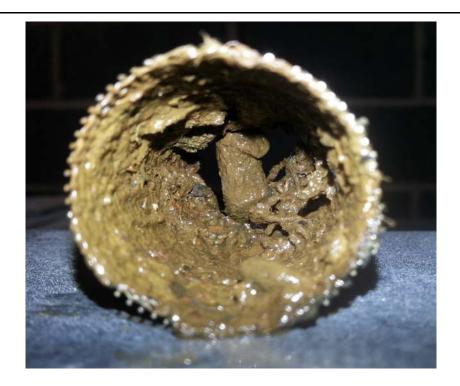
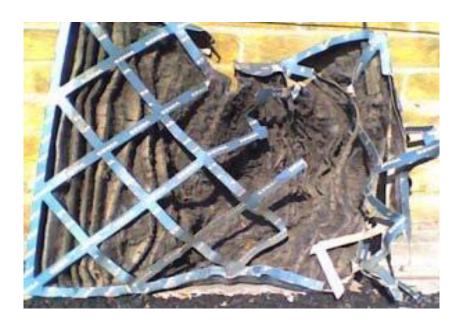
Building had a maintenance contract.
